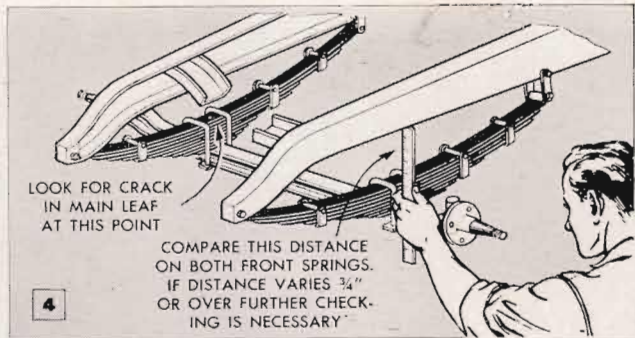
turer for applying lubricant. All leaf springs bend under tension as in the lower detail in Fig. 2 and on nearly all cars more than 10 years old the springs are of the type shown at A in Fig. 3, the ends on all the leaves except the top leaf, Fig. 7. On later-model cars, and on some light trucks, the leaf springs either are fitted with steel covers as at B in Fig. 3, or are of the nonlubricated type detailed at C. On the older-type springs, Fig. 3,A, it may be necessary to loosen the rebound clips and pry the leaves apart in order to apply lubricant between the leaves. Whenever such springs are lubricated always make the checks detailed in Figs. 4, 5 and 6. If measurement from the top of the spring to the lower side of the frame varies more than  $\frac{3}{4}$  in., check the low spring carefully for a broken leaf or excessively worn shackle bolts. Renew faulty parts, as otherwise lubrication of the spring may increase leaf deflection and result in breakage of adjacent leaves. If possible, use the lubricant specified by the manufacturer of the car. Otherwise use chassis grease to which a small quantity of powdered graphite has been added, or use penetrating oil. Don't forget to give the spring shackles and spring clips the same care and lubrication.
