More Hints from the Model Garage

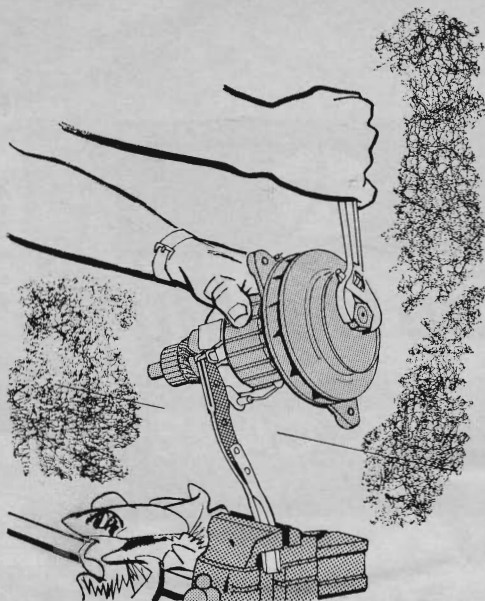
A sticky retainer nut on a generator pulley can be loosened with an oil-filter strap wrench. Place the wrench over the armature and clamp it in a vise. Turning the nut strengthens the grip in the armature, and the nut unscrews easily. To reassemble, reverse the procedure.

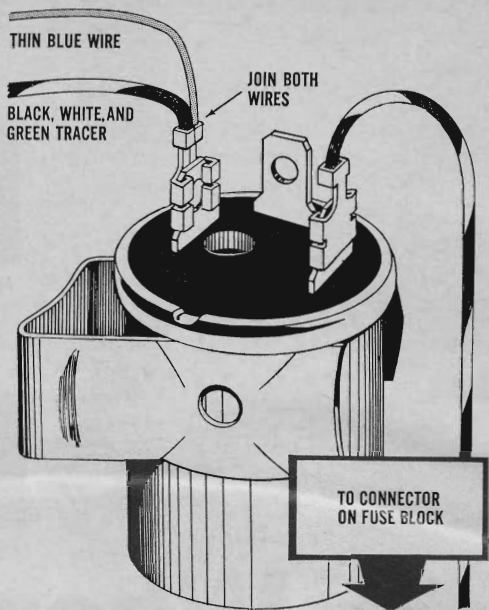
Need a replacement flasher for your VW? The Tung-Sol P-229-D six-volt flasher unit costs about \$1. Join the thin blue wire from the harness to the black, white, and green tracer. This unit flashes immediately, and faster than the one that comes with the VW.

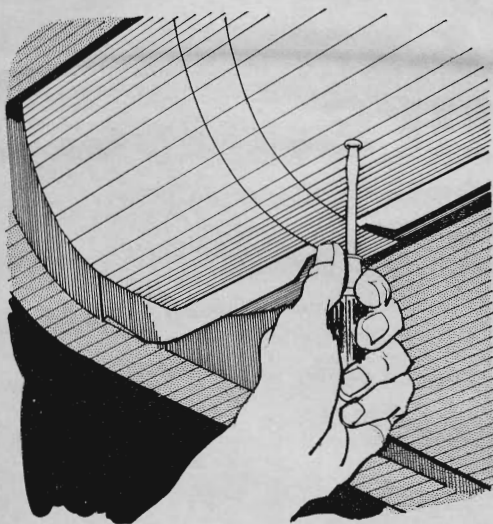
A leaky gas tank can be fixed without draining or removal. Run solder on the threads and under the head of a self-tapping roundhead sheet-metal screw and drive it into the leak site. Tin around the screwhead and solder around it. Avoid red-hot irons or open flame.

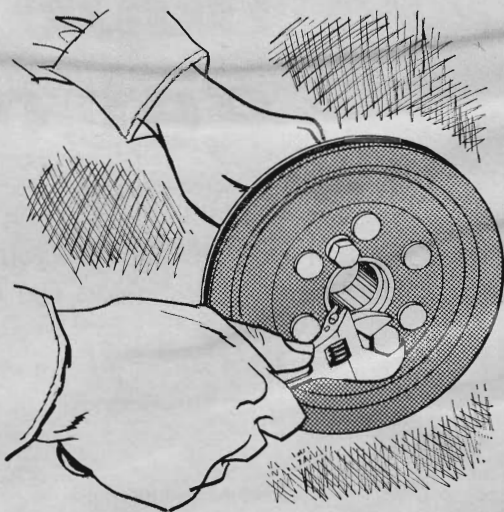
Noisy idling in a Corvair is often a sign that the crankshaft pulley has worked loose from its hub. Fix it by putting two $\frac{1}{2}$ "-by- $\frac{3}{8}$ " standard cap screws with split-type lock washers in the pulley holes. This puts more tension on the pulley and keeps it firmly on the hub.
